Memorandum

From: Steve Willis
To: Wayne Miller
Date: October 25, 2018
Subject: Site visit to inspect the landfill cap at Former Williams Air Force Base Site LF004, September 25, 2018.

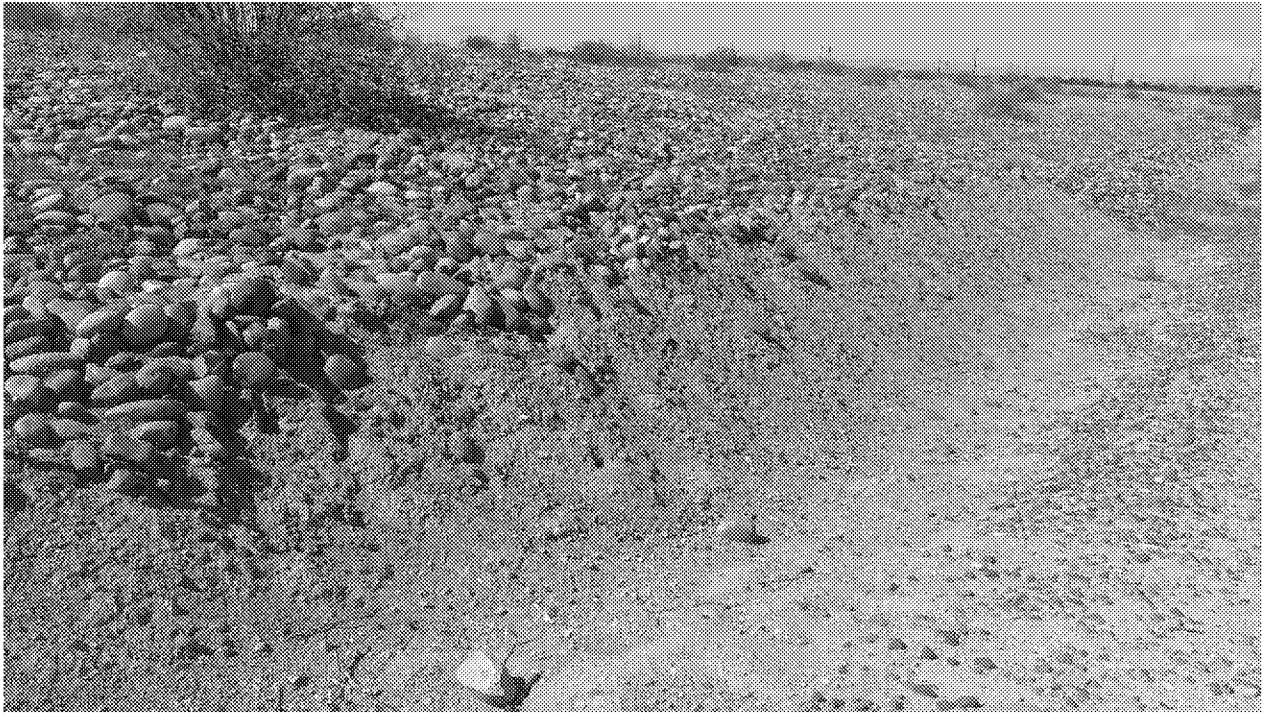
- Photo 10. Erosion under fence near previously repaired area on the north side of the landfill.
- Photo 11. Possible animal burrow at base of the slope on the north side of the landfill.
- Photos 12 and 13. Fissuring at the edge of the north interceptor trench.
- Photo 14. Erosion or animal burrowing beneath the east landfill boundary fence.
- Photo 15. Erosional rills on the east side of the landfill.

Photo 15. Erosional rills on the east side of the landfill.
